URGENT MEDICAL DEVICE RECALL NOTIFICATION

RE: STRYKER Navigation System II-Cart, Articulated Arm Camera

May 18, 2015

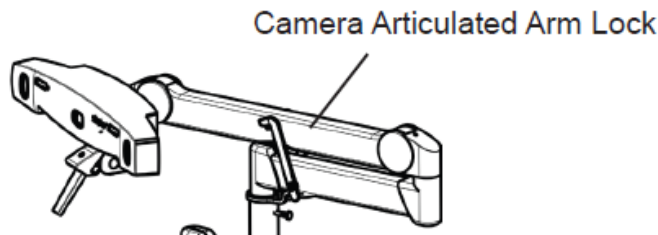
One of the components to the Navigation System II-Cart is the Navigation System Camera; the camera communicates the coordinate location of the navigated instruments to the system. The camera is attached to the Articulated Arm.

Additional inspection is required because there is a potential that the weld seam between the main stud and the two flaps on the Articulated Arm was not welded in the correct location, which may result in a potential failure of the arm joint.

A change in the position of the camera will not impact the accuracy of navigation. A failure in the weld joint could result in the interruption or discontinued use of the Navigation system.

5. Fax (866-521-2762) or email (kellyjo.davis@stryker.com) the completed BRF to Stryker Instruments Regulatory Department, Attn: Kelly Jo Davis.
6. A Stryker Representative will contact your facility to set up a time to perform the additional inspection of the weld seam on the Navigation System II-Cart, Articulated Arm Camera.
